Title: "The Stone House in Herăști. Architectural Study"

Author: Eugenia Greceanu

The Stone House in Herăști Architectural Study¹

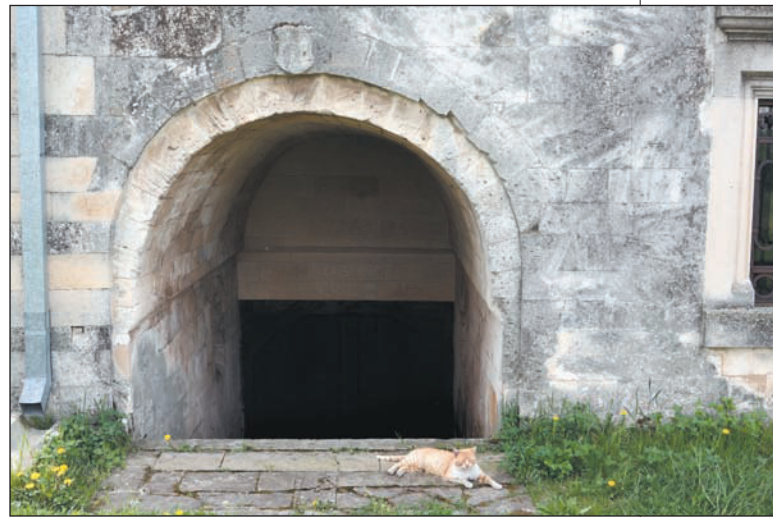
Aligned along the long sides of the building, each of the cellars has its entrance through a vaulted passage, ending up at the façade with an open double archway. Between this entrance passage and the cellar there is a narrow, vaulted chamber, functioning as an antechamber, bordered towards the exterior by a thin wall, initially made of stone and subsequently replaced by a brick wall standing on the current wooden door case. A wooden plank whose traces are perfectly preserved separated the upper part of the room, making up a sort of secret vault, linked to the ground floor by a small door with a stone-carved

ledge. The cellar with the west entrance has only one room, covered by a cylindrical vault between two double-arches. It is lighted through two narrow holes, opening to the south and framed to the interior by flaring conical arches going deep into the cylindrical vault. The north-facing cellar includes, apart from the passage and the entrance hall, a large chamber with a cylindrical vault, supported by a double arch and lighted by two windows of the same type as in the western wing cel-

lar, and another two small rooms, cylindrically vaulted, extending to the eastern end. (...)
